June 27, 2019

City of Birmingham
Department of Planning, Engineering & Permits - Architecture Division
710 20th Street North
Birmingham, Alabama 35203

Subject: Report of Limited Indoor Air Quality and
Limited Asbestos Sampling
Fire Station No. 27
400 Huffman Road
Birmingham, Alabama
Bhate Proposal No. BRE1900.0058.0001

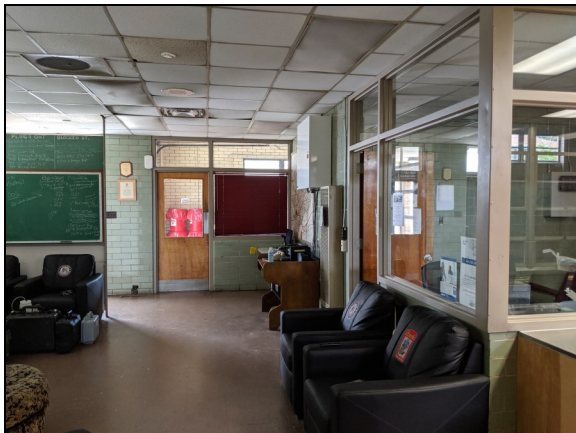
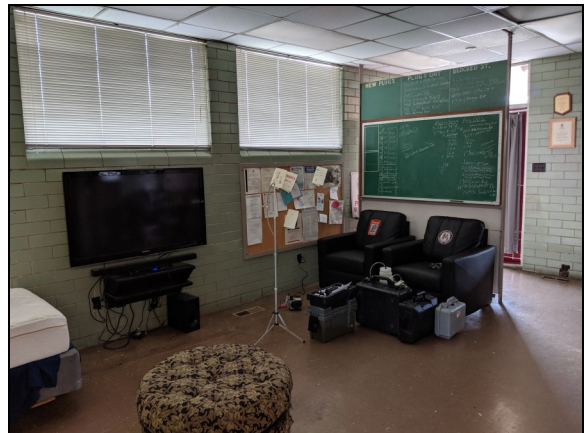
Photo #9
Interior view of day room

Photo #10
Interior view of day room

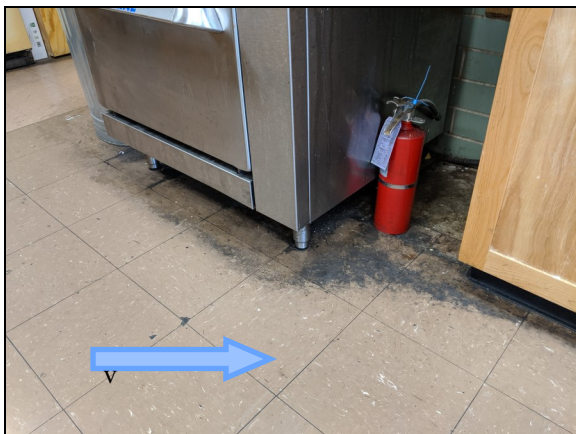
- **All of the floor tile (both 9" x 9" and 12" x 12") located within the structure was identified as containing 3 to 4% Chrysotile asbestos. These materials appeared to be in fair condition with the exception of the 12" x 12" black floor tile in Dormitory #1, which was observed to be in poor condition.**
- **The black adhesive associated with the 12" x 12" floor tile was identified as containing 4 to 6% Chrysotile asbestos. This material appeared to be in fair condition.**
- **Additionally. It should be noted that the leveling compound associated with the floor tile sample collected from the Day Room Closet was identified as containing <1% Chrysotile asbestos. This material appeared to be in fair condition.**

Photo #23
View ACM (12" x 12" brown floor tile with white streaks and mastic) in kitchen and day room

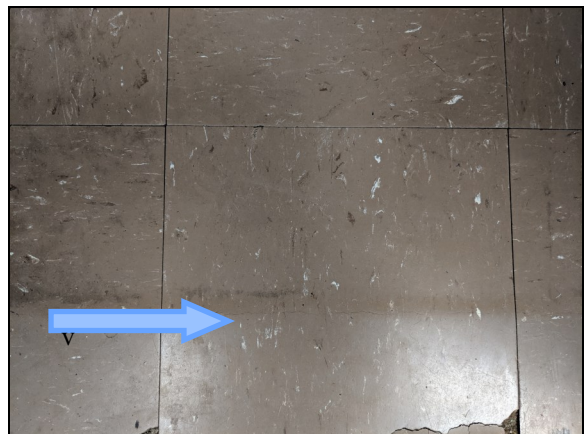
Photo #24
View ACM (12" x 12" brown floor tile with white streaks and mastic) in dormitory #1

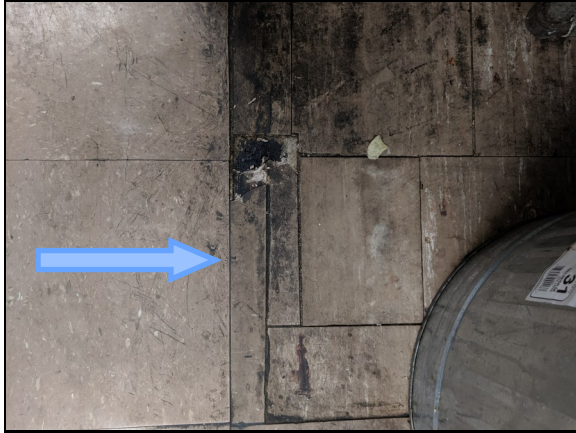
Photo #25
View of ACM (9"x 9" light brown floor tile with pink and white streaks beneath 12" x 12" floor tile

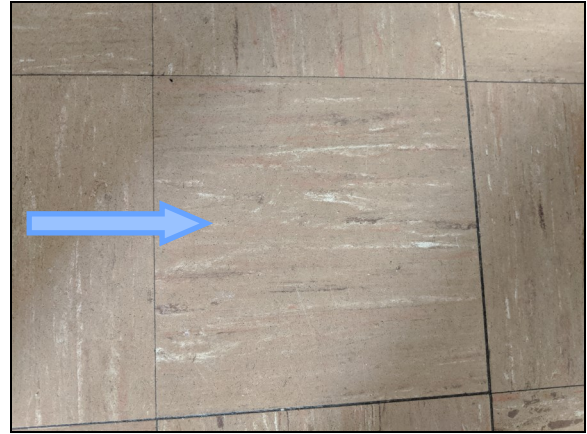
Photo #26
View of ACM (9" x 9" Light brown floor tile with pink and white streaks) in office #1

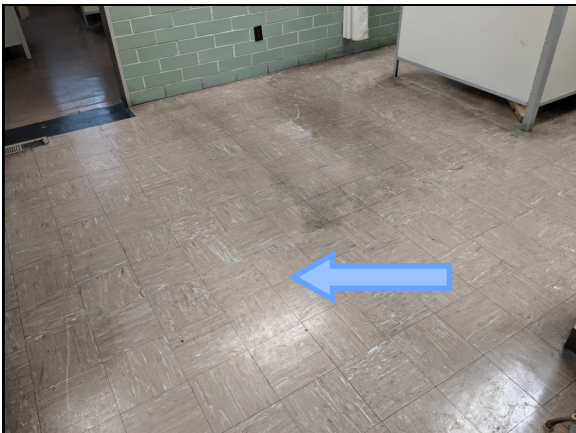
Photo #27
View of ACM (9" x 9" light brown floor tile with pink and white streaks) in dormitory #1

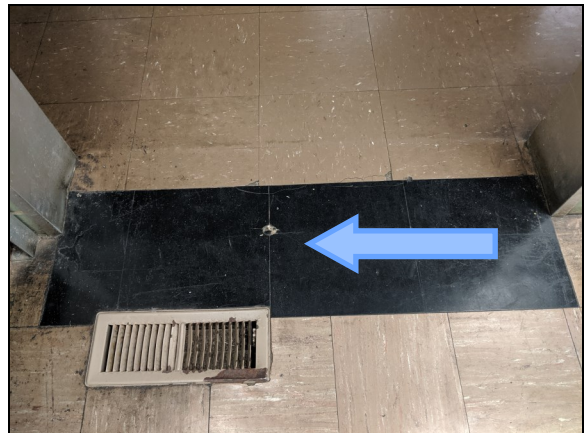
Photo #28
View of non-ACM (12" x 12" black floor tile and mastic) in dormitory #1

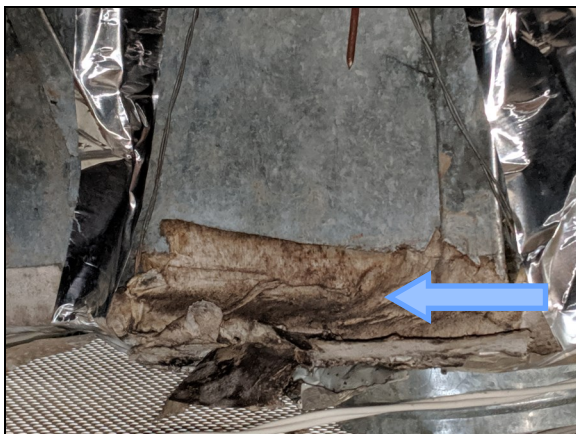
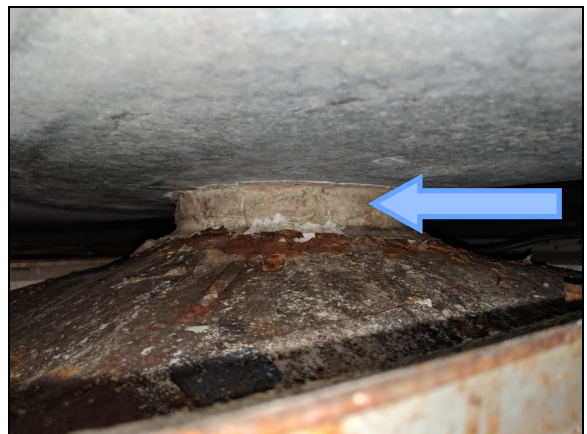
- **White HVAC tape on HVAC duct above drop ceiling was identified as containing 40% Chrysotile asbestos. The material was observed above the drop ceiling in dormitory #1 and appeared to be in fair condition.**

Photo #29
View of ACM (white HVAC tape) above drop ceiling in dormitory #1

Photo #30
View of ACM (white HVAC tape) above drop ceiling in dormitory #1

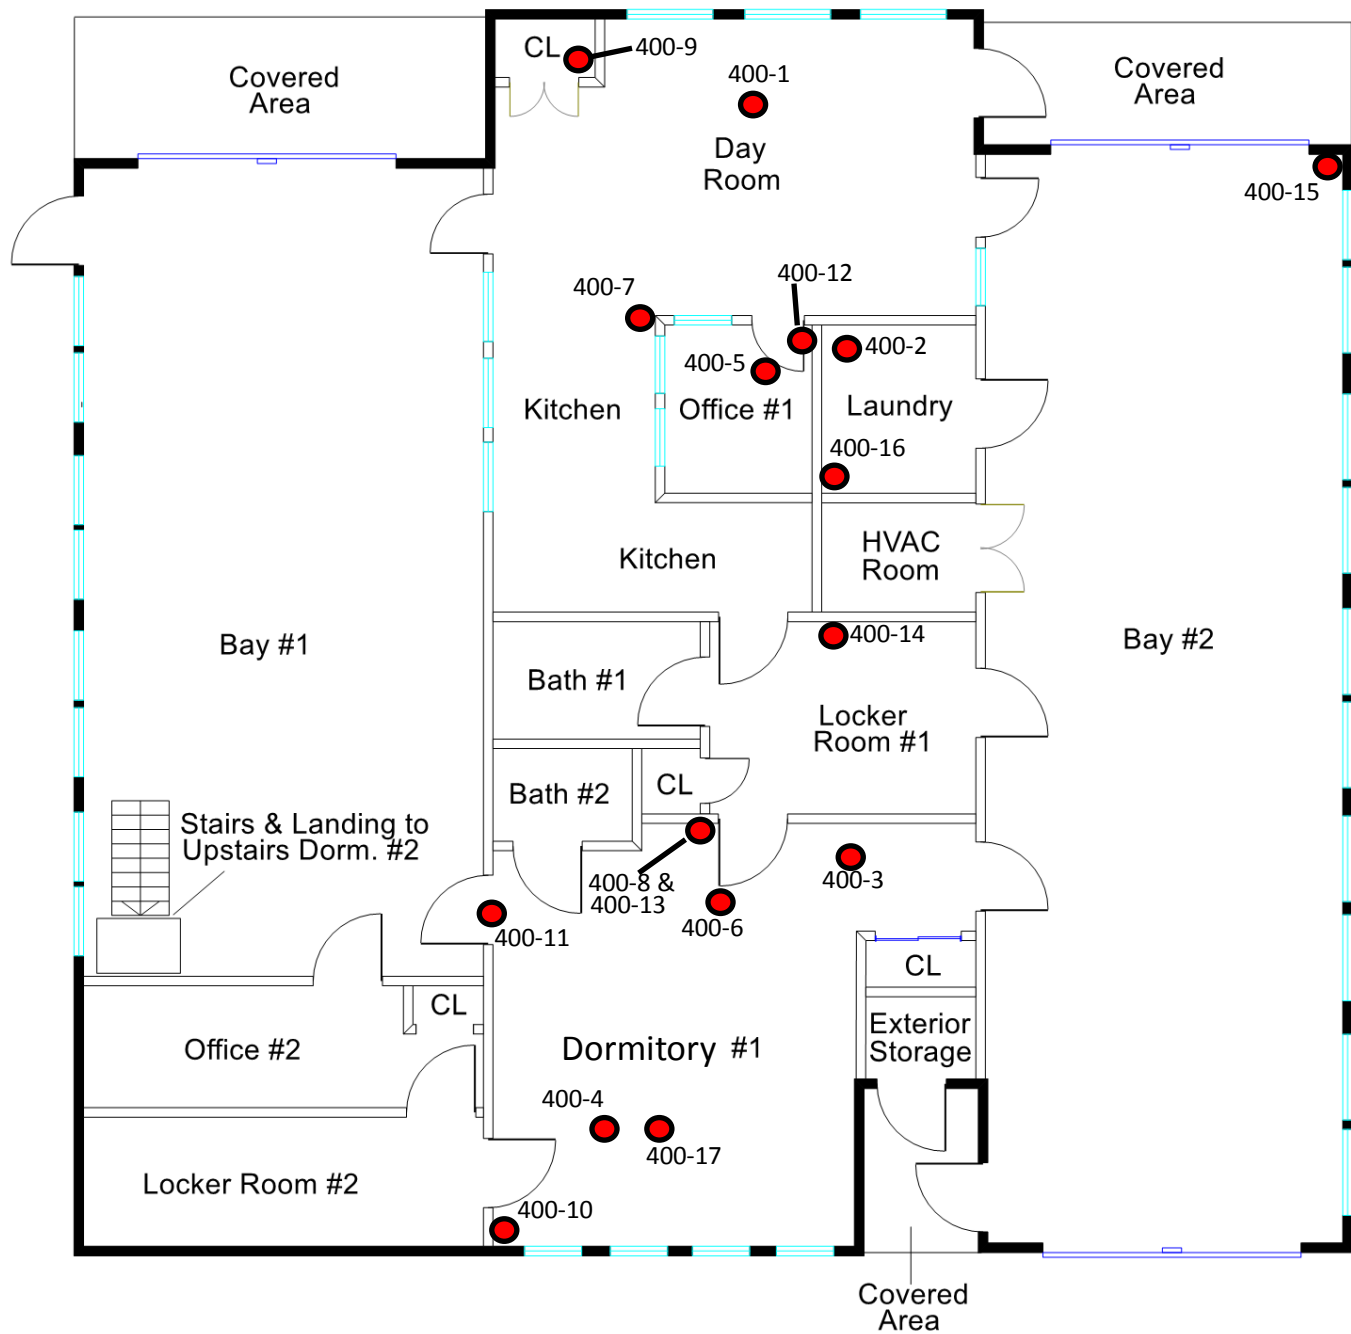
Figure D-1

ASBESTOS SAMPLING LOCATIONS

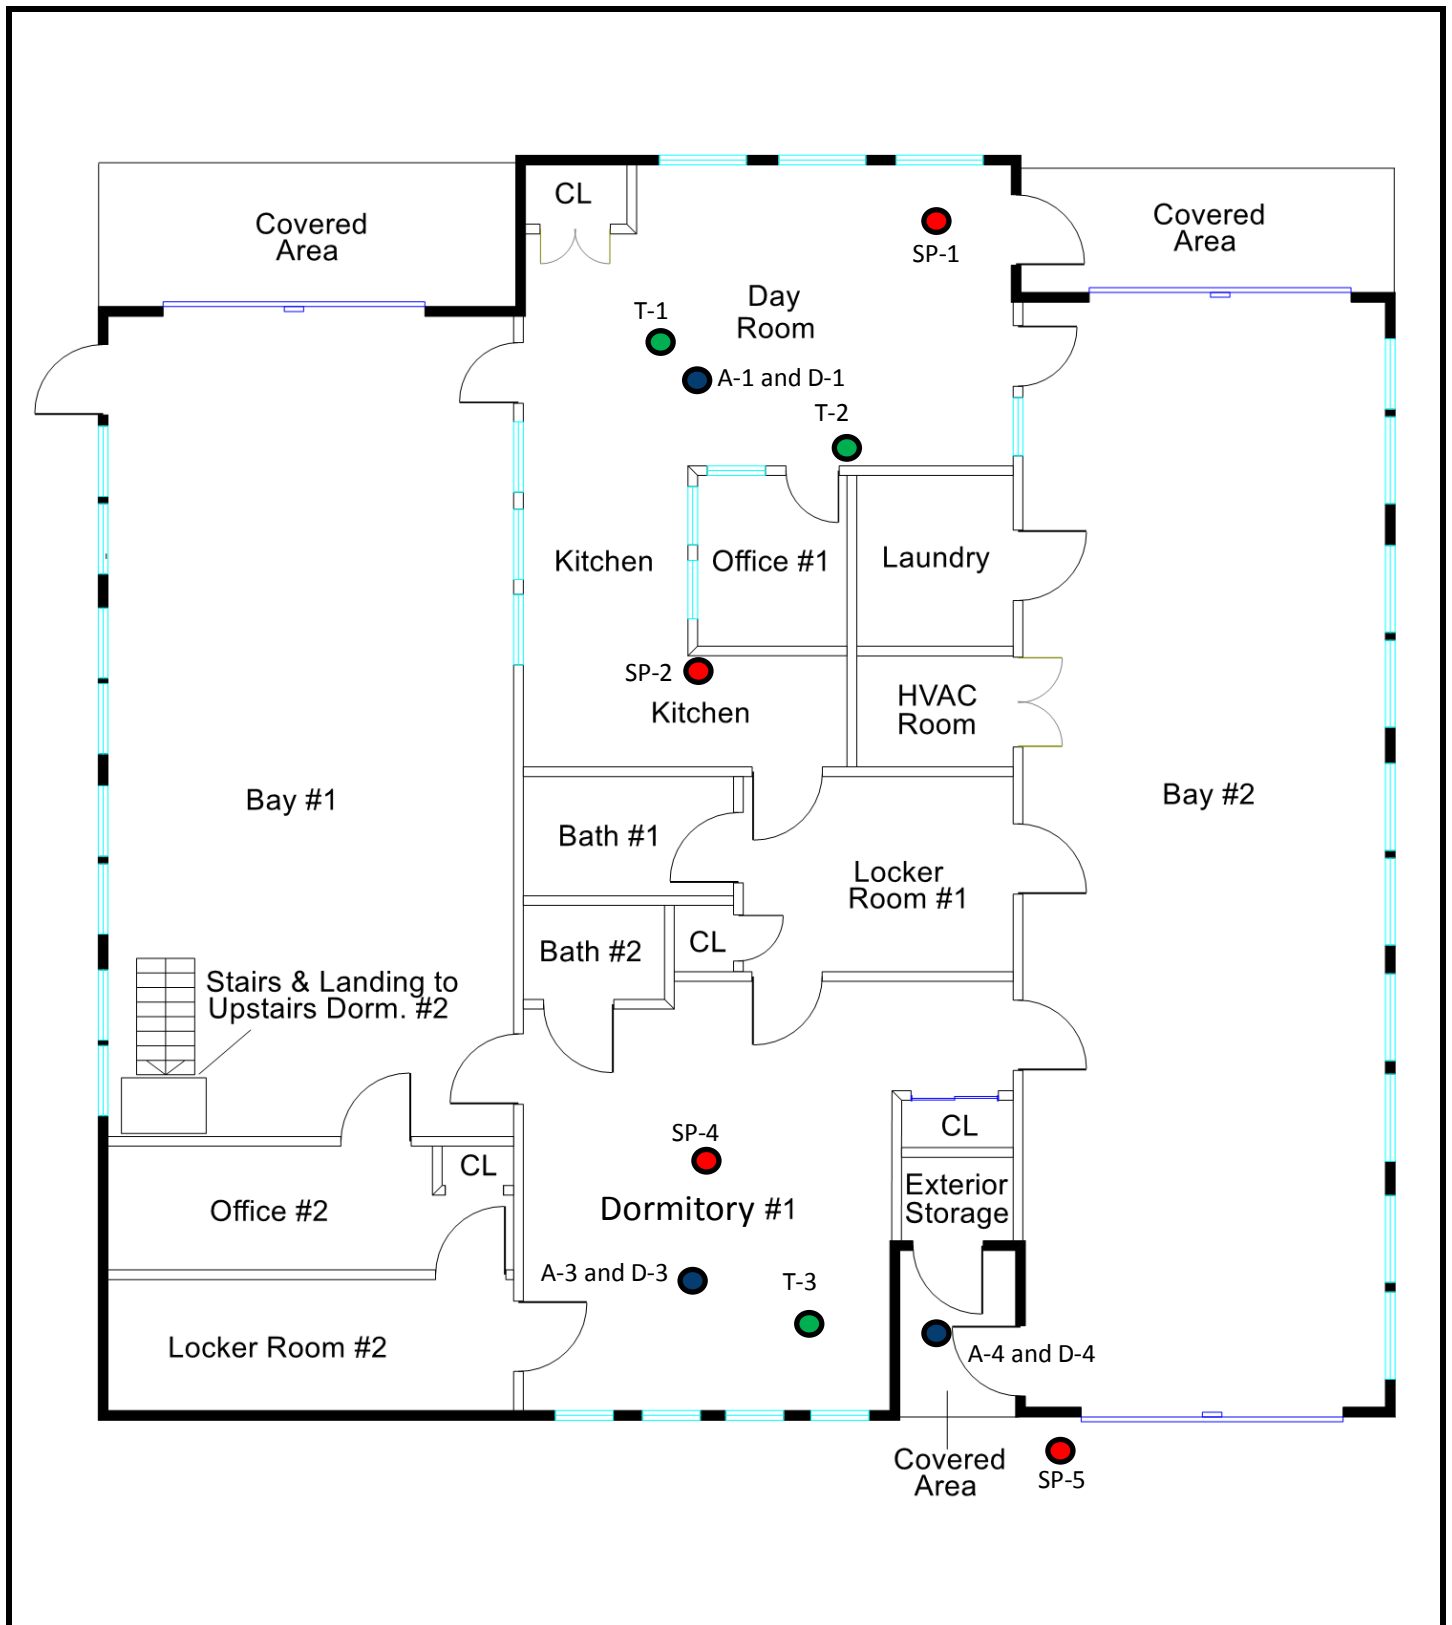
Figure D-2

AIR SAMPLING AND TAPE LIFT SAMPLING LOCATIONS 1ST FLOOR

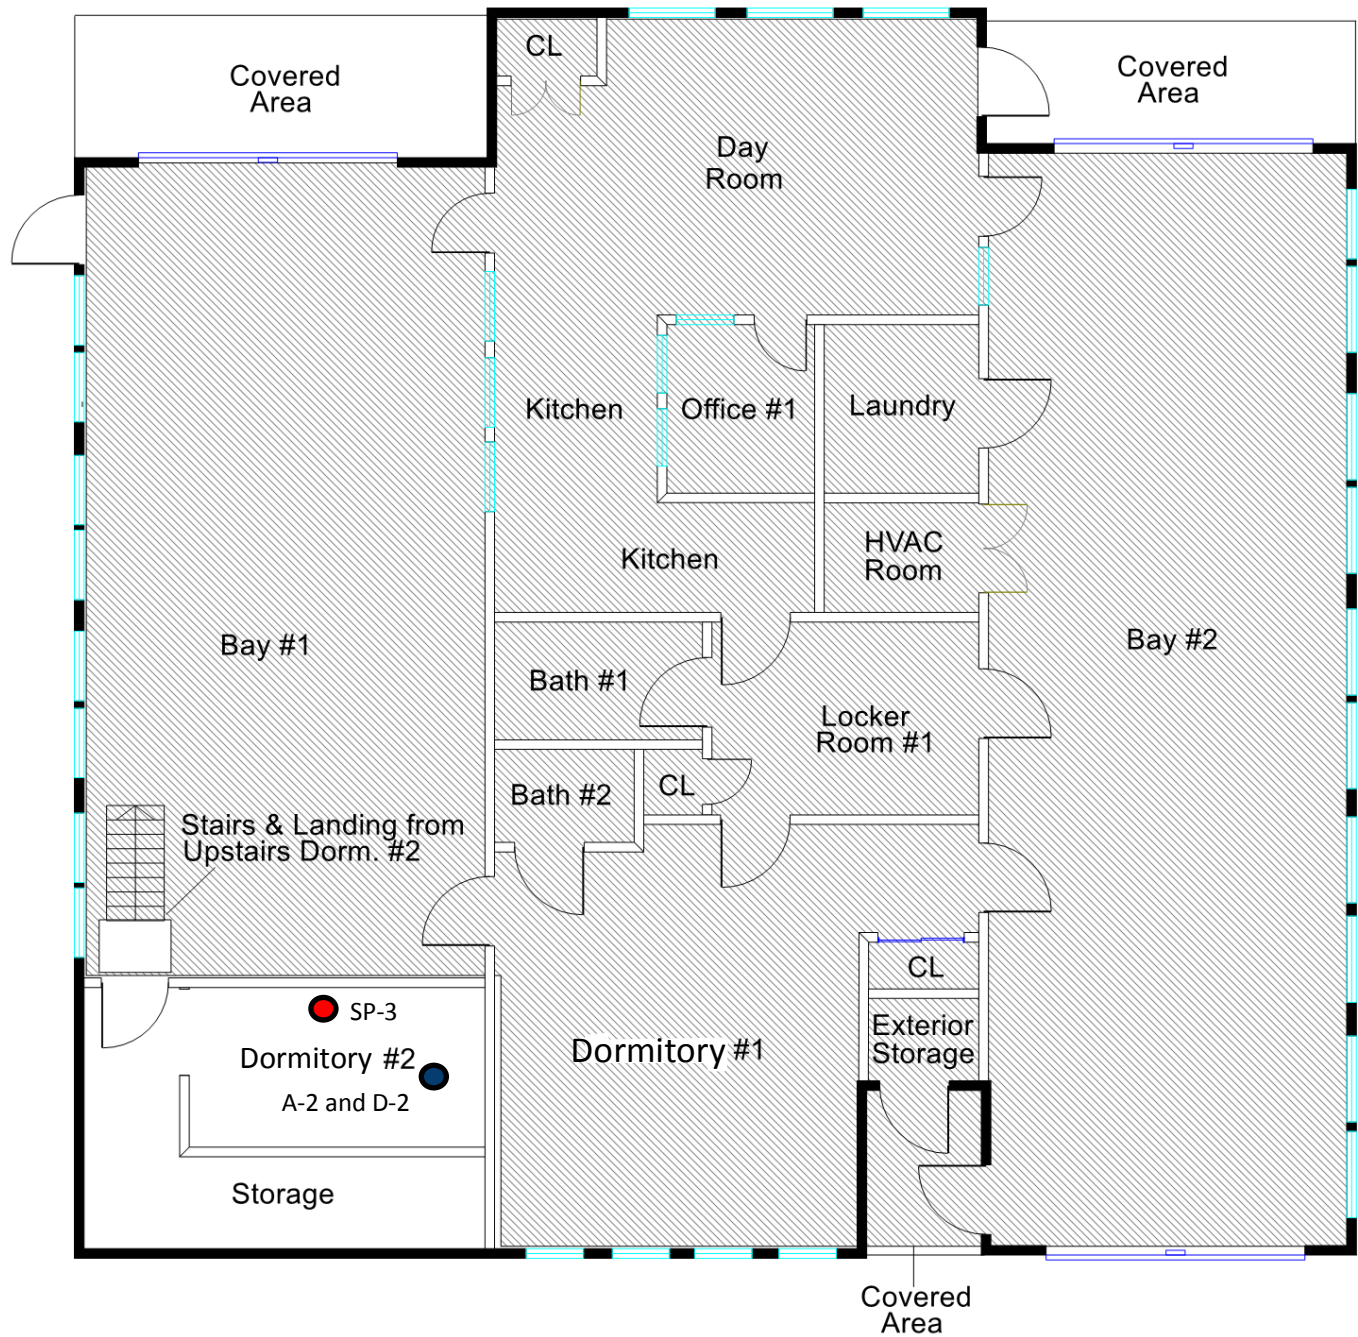
AIR SAMPLING AND TAPE LIFT SAMPLING LOCATIONS 2ND FLOOR
